2020 AHERA THREE-YEAR RE-INSPECTION REPORT FOR THE BETHEL HIGH SCHOOL

Prepared for

Bethel Board of Education

Bethel, Connecticut

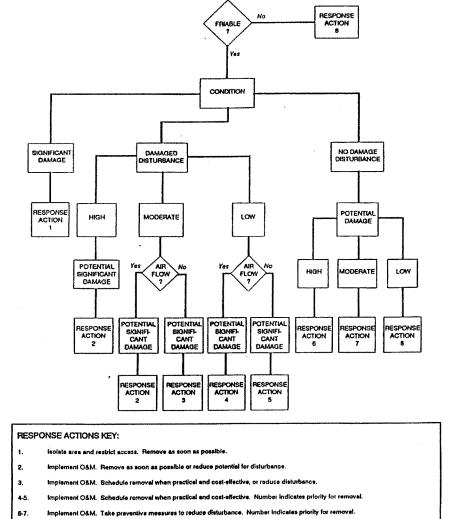
FIGURE III-a EPA Decision Tree and Response Actions

EPA DECISION TREE AND RESPONSE ACTION KEY

Hazard Assessment Summaries and specific recommended response actions for ACBM located in the Bethel Public School buildings and administrative office areas are included in the following tables. Refer to **Figure III-a** for the USEPA Decision Tree and subsequent response action key.
